# sinclair

ZX Spectrum

ZX Spectrum+

# Service Manual

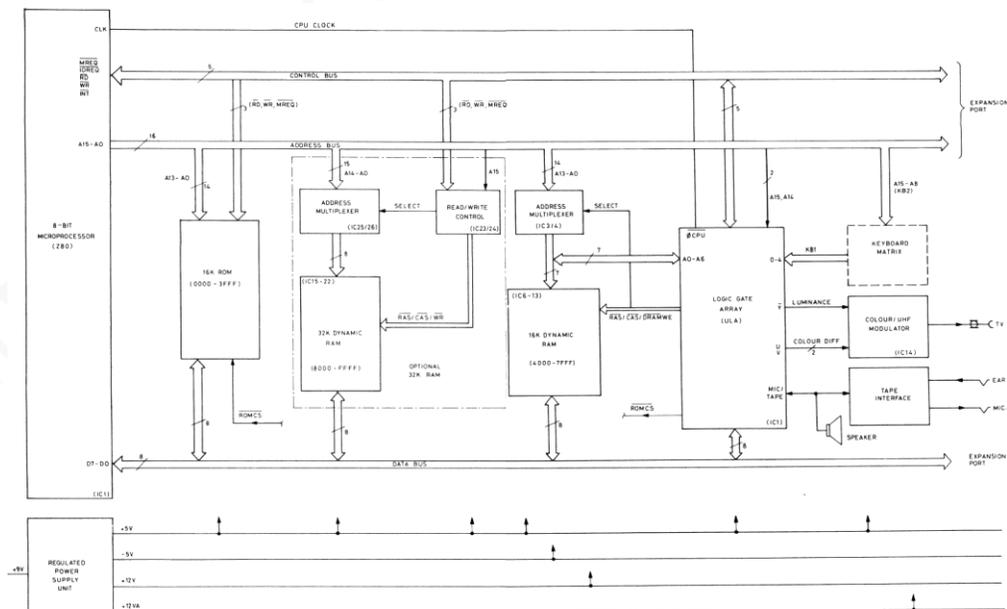
A block diagram of the complete ZX Spectrum micro-computer is given below. It is valid for all build standards, fitted with either 16k or 48k bytes of dynamic RAM memory. Although functionally identical, detailed circuit changes have been introduced to improve reliability and to assist with manufacture. The printed circuit board layout has also been modified. Details of these changes are highlighted where necessary in the following paragraphs, and in later sections referring to logic fault diagnosis and repair.

The architecture of the Spectrum shown above is typical of many microcomputer systems in that it comprises a single microprocessor board (in this instance a Z80A or u780 CPU), a read only memory (ROM), an expandable RAM memory and an input/output section handling the keyboard, tape and TV display functions. The latter is recognisable as the logic gate array (ULA) and the three functional blocks shown in the right of the diagram.

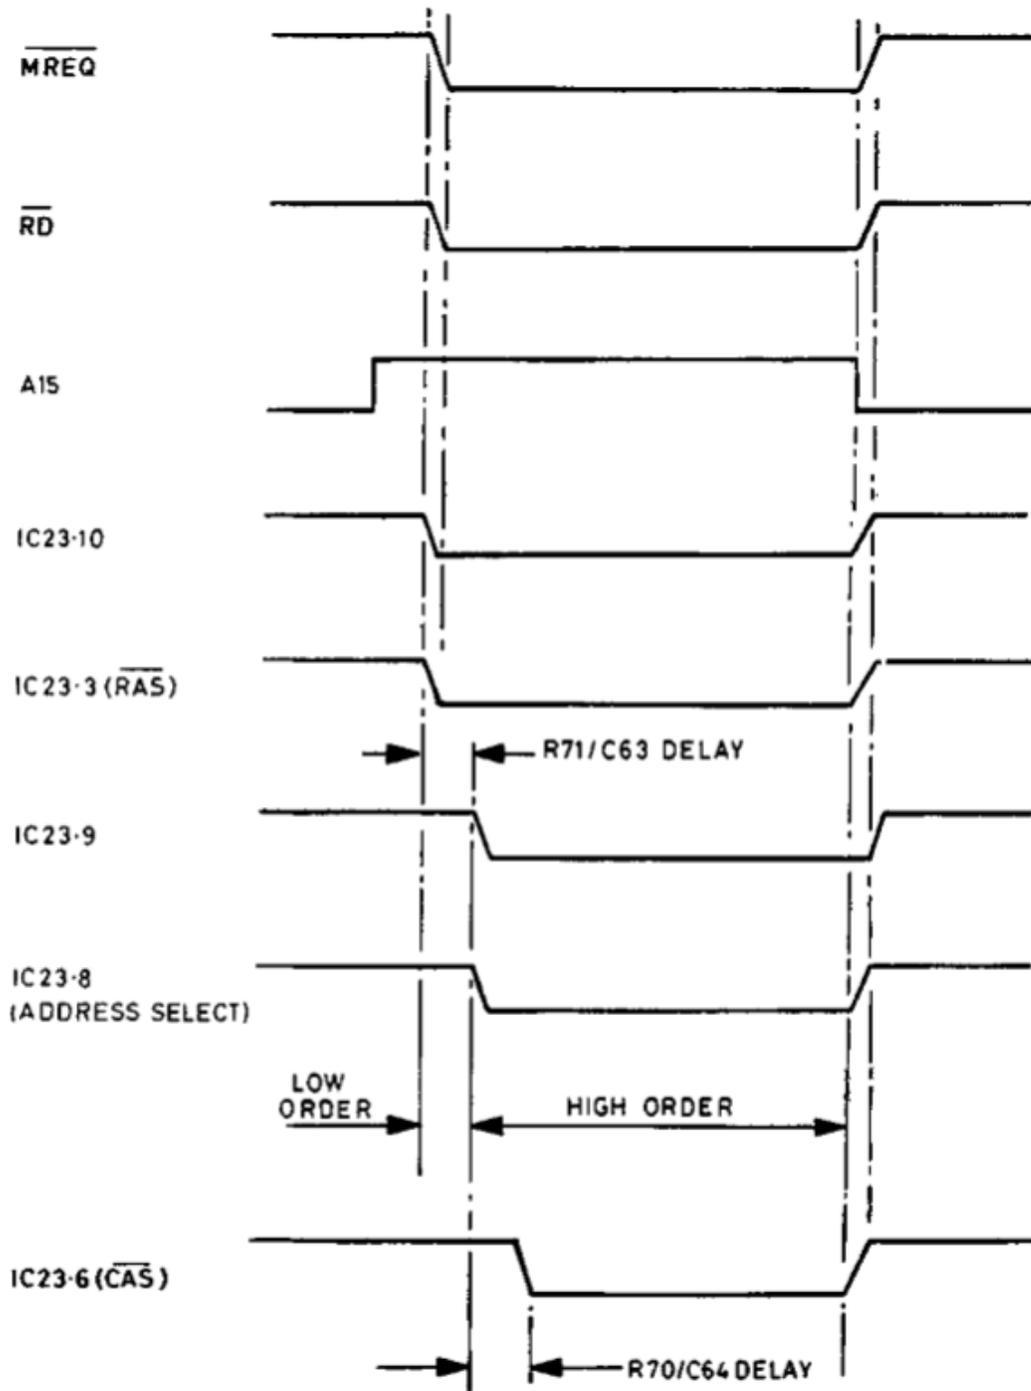
Row/column address selection and RAS/CAS timing for the RAM is decoded in IC23/IC24 from inputs supplied by the CPU, i.e. address line A15 selecting addresses 8000 upwards, and MREQ heralding a memory read or write cycle. A theoretical timing diagram is shown on the next page.

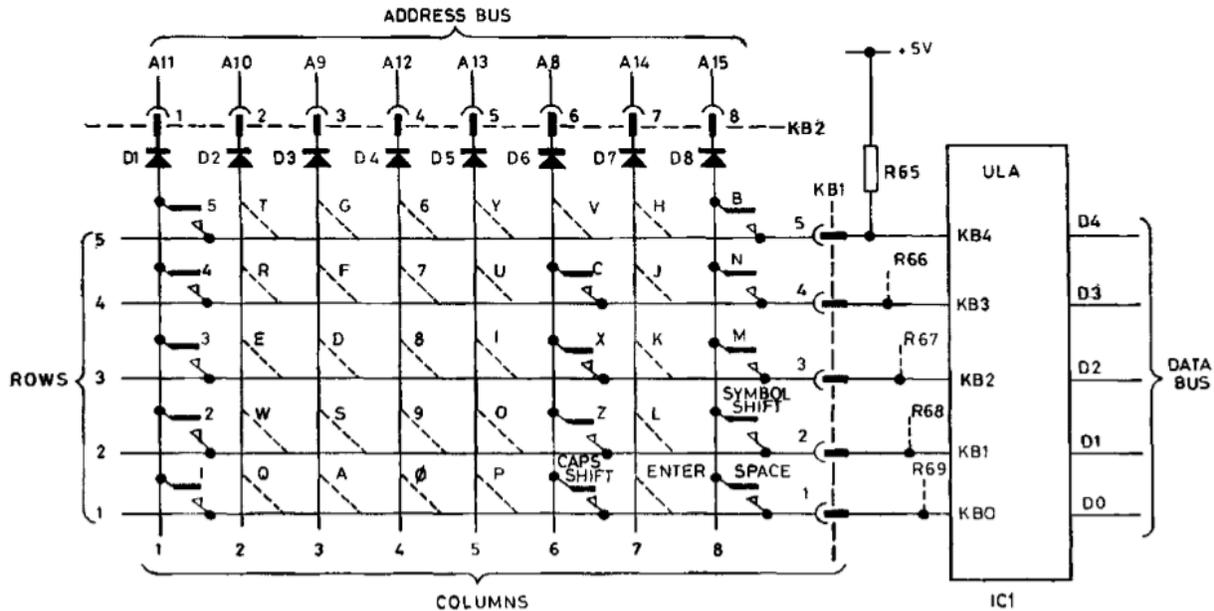
Every 20ms (i.e. once per maskable interrupt), the CPU systematically scans the keyboard recording which keys (if any) have been pressed. The scanning method is described below with the aid of the diagram below. As the diagram clearly illustrates the keyboard consists of an 8 x 5 matrix, the inter-section of each row and column bridged by a normally open switch contact. The row `outputs` and column `inputs` are shown connected by separate ribbon cables KB1 and KB2, one to the ULA and the other to the high order address lines A15-A8. Pull-up resistors R64 through R68 ensure that when the address bus is in the high Z state, or none of the key-switches is closed, row outputs KB0 to KB4 remain high.

When the keyboard scanning routines are entered the CPU performs successive I/O read cycles setting the IOREQ and RD lines to the ULA, low. At the same time, the I/O port addresses placed on the upper half of the address bus are modified with each cycle such that each of the address lines A15 through A8 is set low in turn, the other lines remain high.

The sequence starts with I/O port address FE driving address line A8 low. The keyboard matrix also sees this potential on column 6 applied via D6 and the ribbon cable KB2. Thus, when any of the switches on the inter-section with column 6 is pressed, the corresponding row output supplying the ULA via the second ribbon cable (KB1), is pulled low. The row signal(s) is subsequently inverted by the ULA and placed on one of the five low order data bus lines. For example, if the CAPS SHIFT key is pressed row one output drives data bus D0 high and so on. The sequence ends with I/O address 7F when column 8 is addressed. In this instance, operation of the SPACE key drives D0 high. Clearly, the keyboard scanning routines make the distinction between the CAPS SHIFT and SPACE key by knowing which address line is being driven.

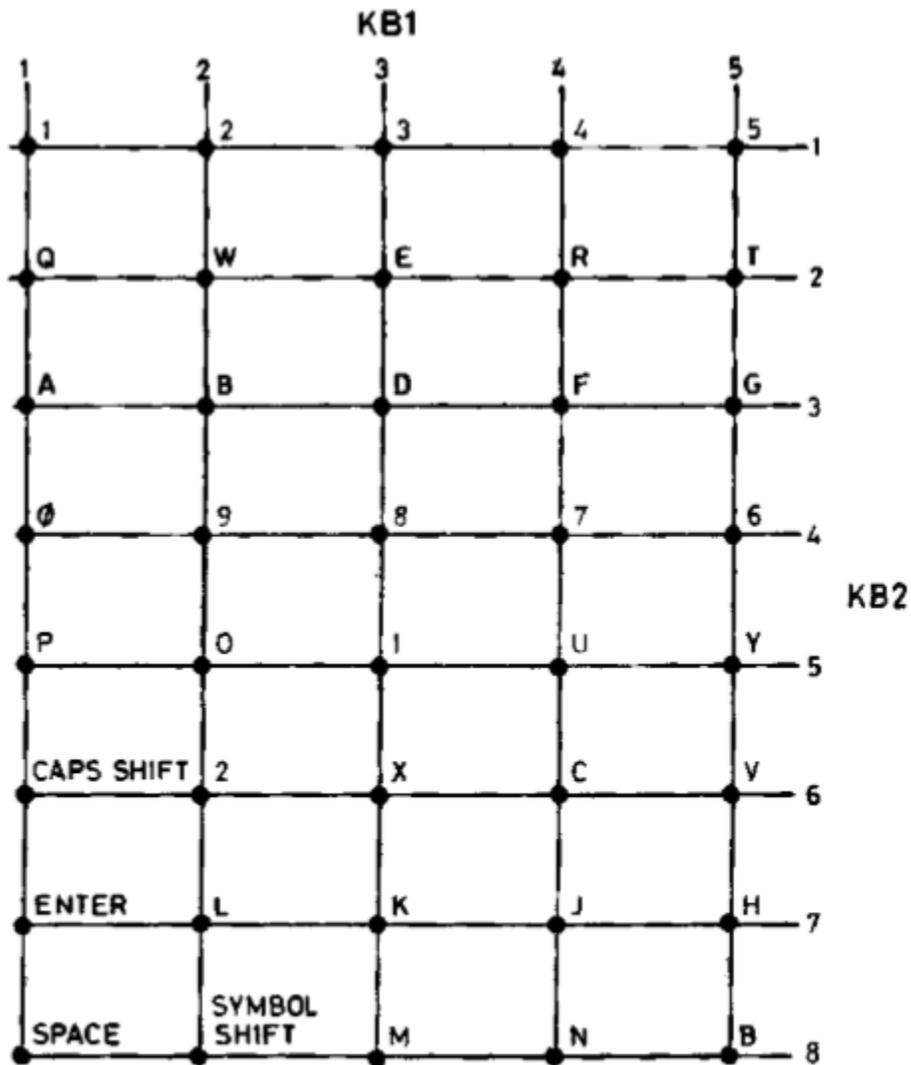
## 5.5 KEYBOARD STRUCTURE

The keyboard is connected horizontally in eight blocks of five keys and vertically in five blocks of eight keys. The diagram below shows the configuration. It follows that if any block of five keys fail the fault is with KB2 circuitry or the 8-way membrane, and that if any block of eight keys fail the fault is with KB1 circuitry or the 5-way membrane.

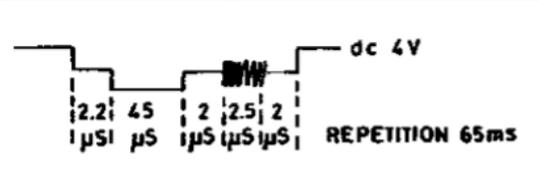
IC14 (LM1889) Pin Signals

5	(Ground) 0V
12	(Video input) DC 12V unregulated
13	(Chroma subcarrier)

14	(RF Supply)
15	(Sound tank) 'Linked' 12V DC
16	(Chroma supply)
17	(Chroma oscillator output) Square wave 0.2us 4V p-p 0.8V DC
18	(Chroma lag) Sine wave 500mV p-p 2us 9.5V DC
6,7,8,9,10,11	Not connected

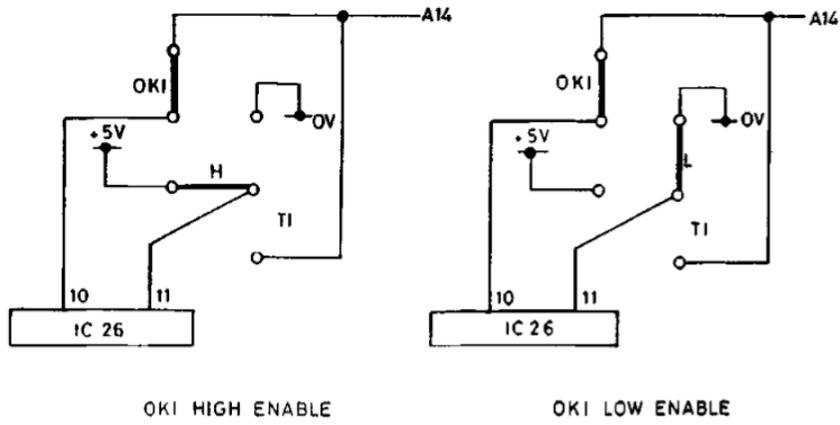
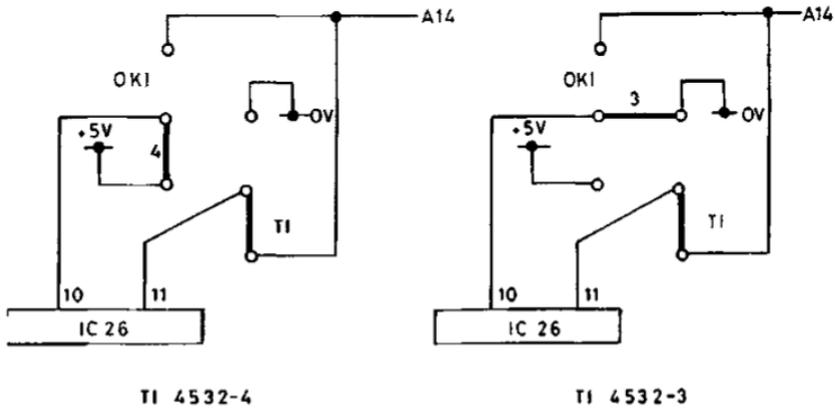
### 7.3.4 Issue 3 Links vs IC Manufacturer and Type

- All extension RAM ICs must be of the same type.
- Two links must be fitted on the board (grid located between edge connector and mic jack socket) depending on memory manufacturer and type (high or low enable).

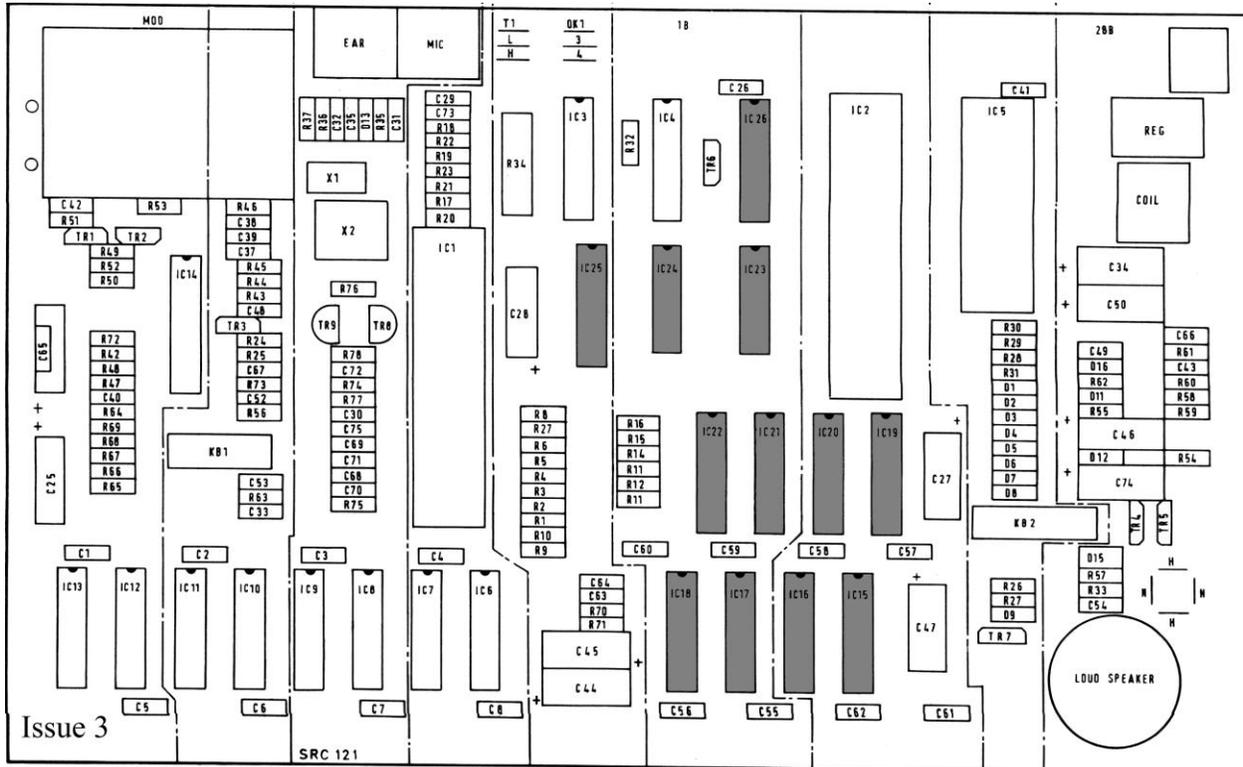
### 7.3.5 Expansion Memory IC Locations

Shaded areas denote expansion IC locations.

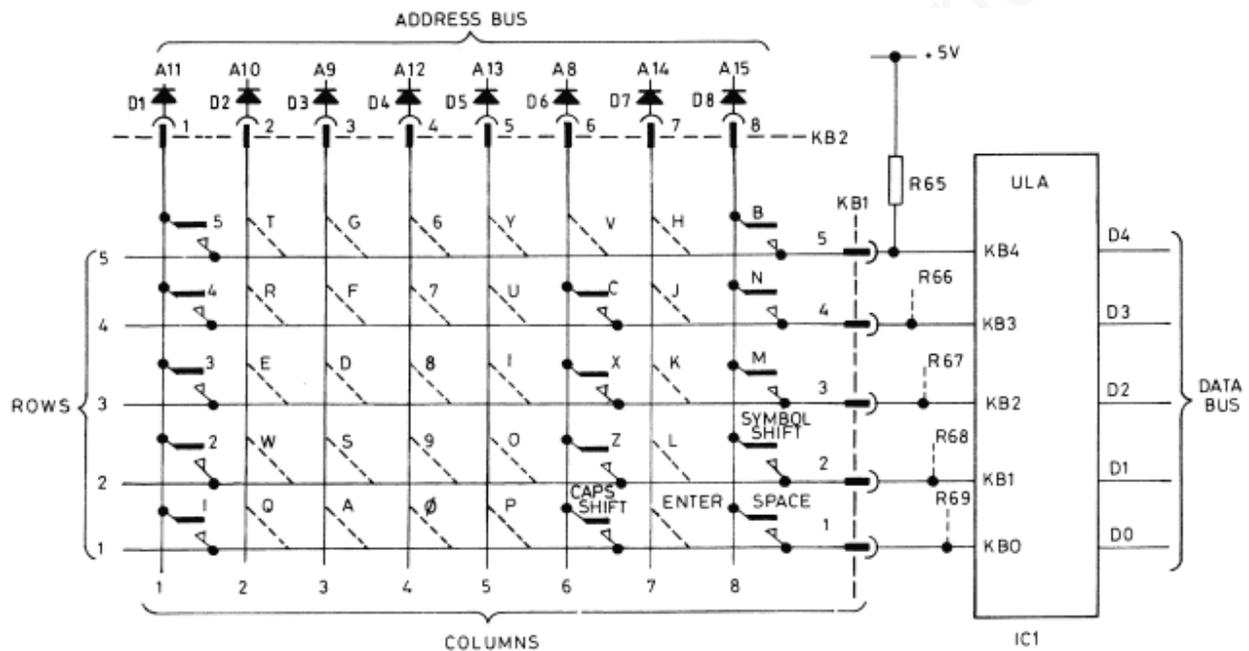
### 10.5 SPECTRUM + KEYBOARD – TOP MEMBRANE

For example, pressing the full stop key connects row 2/column 8 on the top membrane as well as row 3/column 8 on the lower membrane.
